# Team Product Document

GO Number 97055	S/A Number 32120	Page 1 of 59	Total Pages 59	Rev. Ltr/Chg. No. See Summary of Chg. New	Number EID-08640
Program Title Closure of ETEC (R21-RF)					
Document Title Building 4059 (SGPTF) Decontamination and Decommissioning Final Report					
Document Type Engineering Information Document			Related Documents		
Original Issue Date 05-02-2005		Release Date <b>RELEASE</b> 05-02-05 CV		Approvals Date	
Prepared By/Date R. D. Meyer D. M. Trippeda		Dept. 694 117	Mail/Addr T038 T038	B. D. Sujata	
IR&D Program? Yes <input type="checkbox"/> No <input checked="" type="checkbox"/> If Yes, Enter Authorization No.					
Distribution			Abstract

Building 059, designated as the SNAP Ground Prototype Test Facility (SGPTF) is one of a number of former nuclear test facilities that has been decontaminated and decommissioned at the Santa Susana Field Laboratory (SSFL). The SGPTF has been completely dismantled with all components and materials removed. This report documents the decontamination and dismantlement activities performed at the facility, which occurred over the time period of 1970 through 2004. Building 059 has more recently been referred to as Building 405

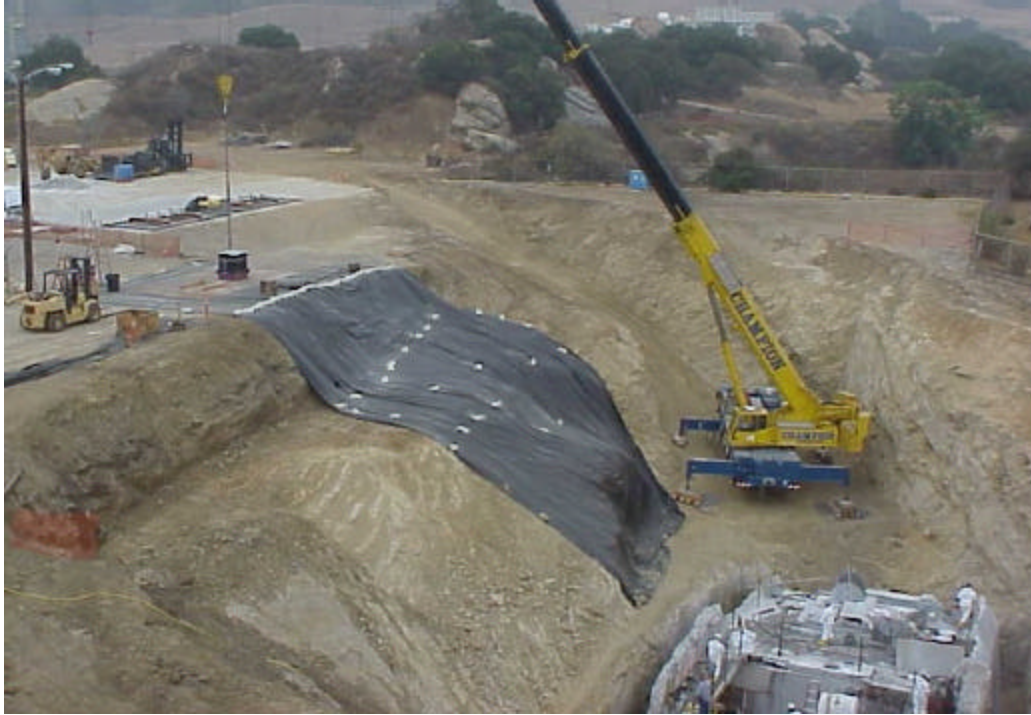
*Figure 2.6.1.1 SGPTF Excavation Looking West*

One of the initially problematic site issues for the new excavation leading to the final demolition of Building 059 was a bedding strike of very loose shale and siltstone tilted at a 35 degree angle toward the north side of the building. The south side of the site was the most accessible to build ramps and stage equipment, but because the shale bed was subject to failure, engineering assessments recommended not using heavy equipment on the south side. Extensive shoring was prohibitively expensive and shallow sloping left equipment too far away from the facility structure. The crane to be used to lift the 20,000 pound blocks would have to be located elsewhere. The selected site design concept was to locate the crane west of the building at the 40 foot below grade elevation. This location and elevation allowed the crane to be within 95 feet of the farthest “pick point” of any block and to be able to lift any block to the staging area above without exceeding the lift parameters for the 180 ton capacity crane. The area chosen for the access ramp to move men and heavy equipment into the work area was on the north side. The selected arrangement maximized the excavation of the relatively soft shale material (as opposed to the relatively hard sandstone) during the crane access and north access ramp installation. Using a crane to remove the blocks eased the movement of supplies, light equipment, vessels containing cutting water, etc. to be placed on pallets and ‘flown’ in and out of the excavation using the crane. The excavation final design is reflected in the post excavation photographs in Figure 2.6.2.1 and 2.6.2.2

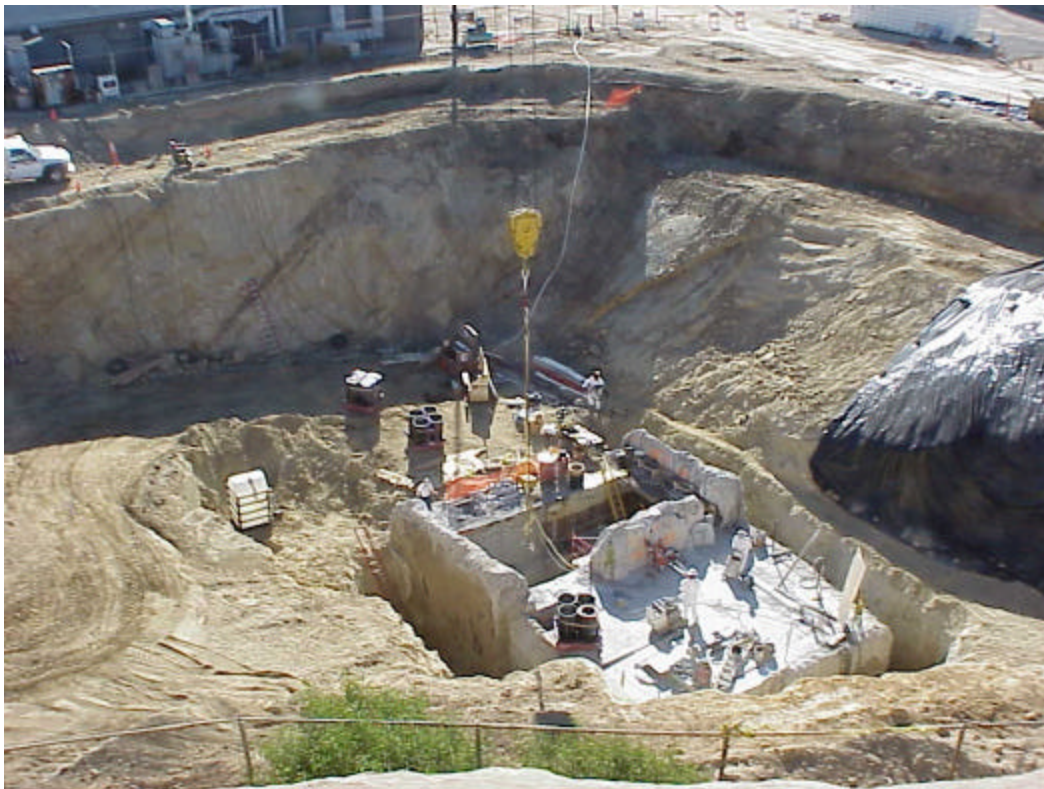
*Figure 2.6.1.2 SGPTF Excavation Looking East after Upper Building Demolition*

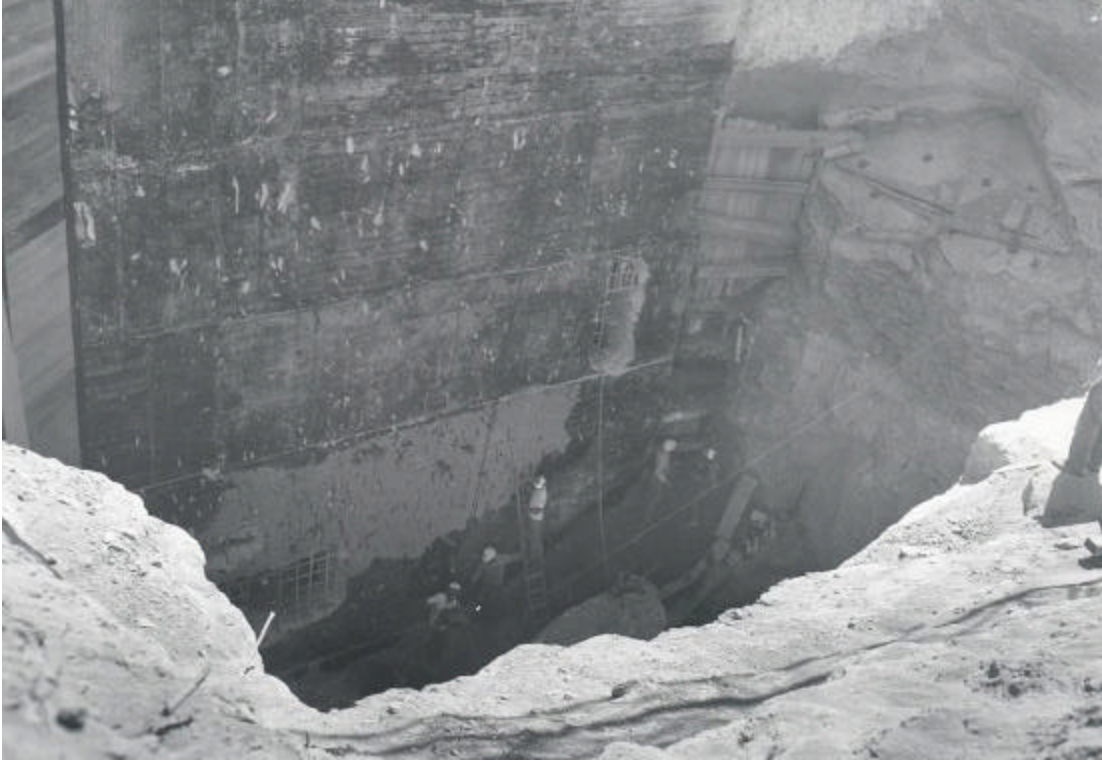
*Figure 2.6.2.3 West Addition Excavation in 1964 Showing Rock Bolts in Shale Bed at Upper Right*

Evidence of the type of geology at the Building 059 site can be seen in construction photos taken during the west addition to the original facility in 1964. In Figure 2.6.2.3, rock bolts installed to prevent wedge failure in the original excavation can be seen near the right side of the photograph. The photos show the 1964 addition was constructed with nearly vertical excavation walls as seen in Figure 2.6.2.4.

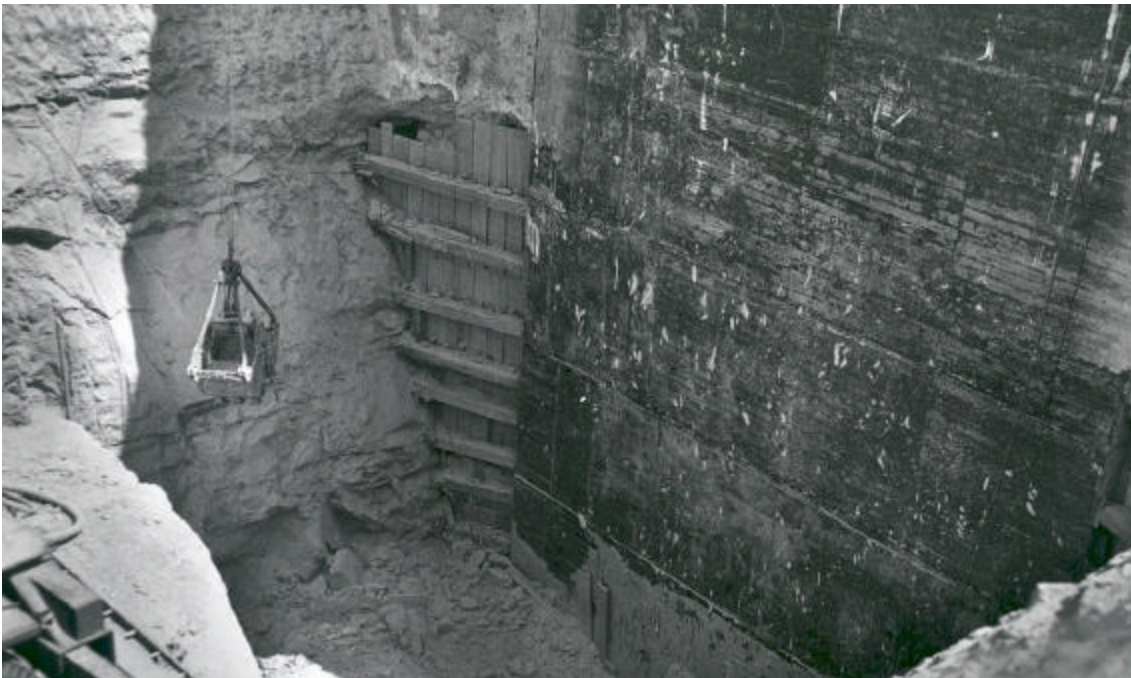
*Figure 2.6.2.4 West Addition Excavation in 1964 Showing Vertical Walls of Excavation*

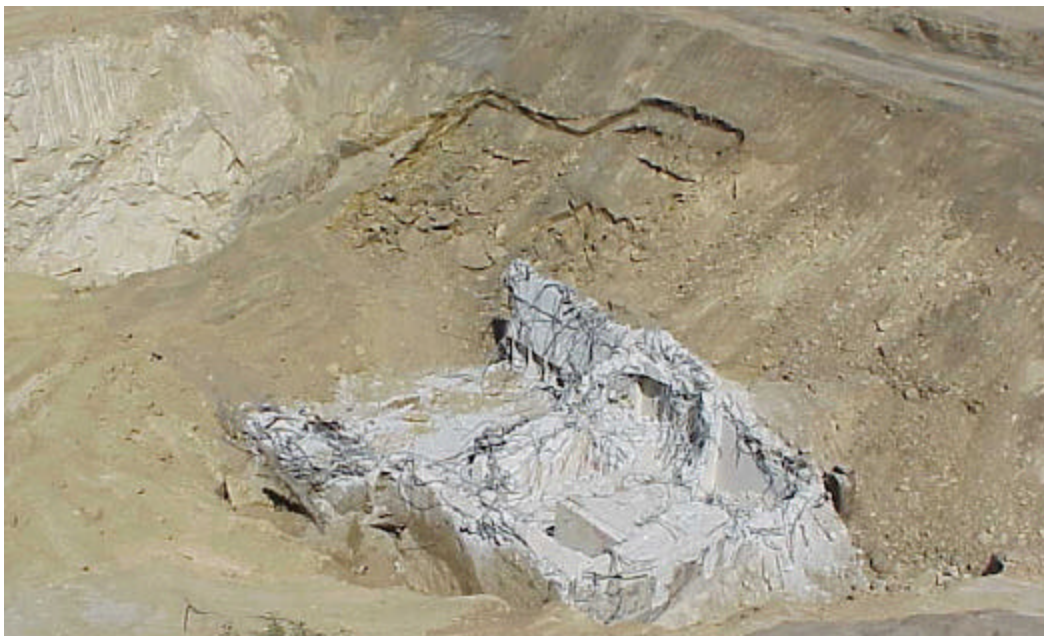
*Figure 2.6.3.4 Demolition of Released Portion Nearly Completed  
(Note Weak Shale Area at Upper Center and Hard Rock at Upper Left)*

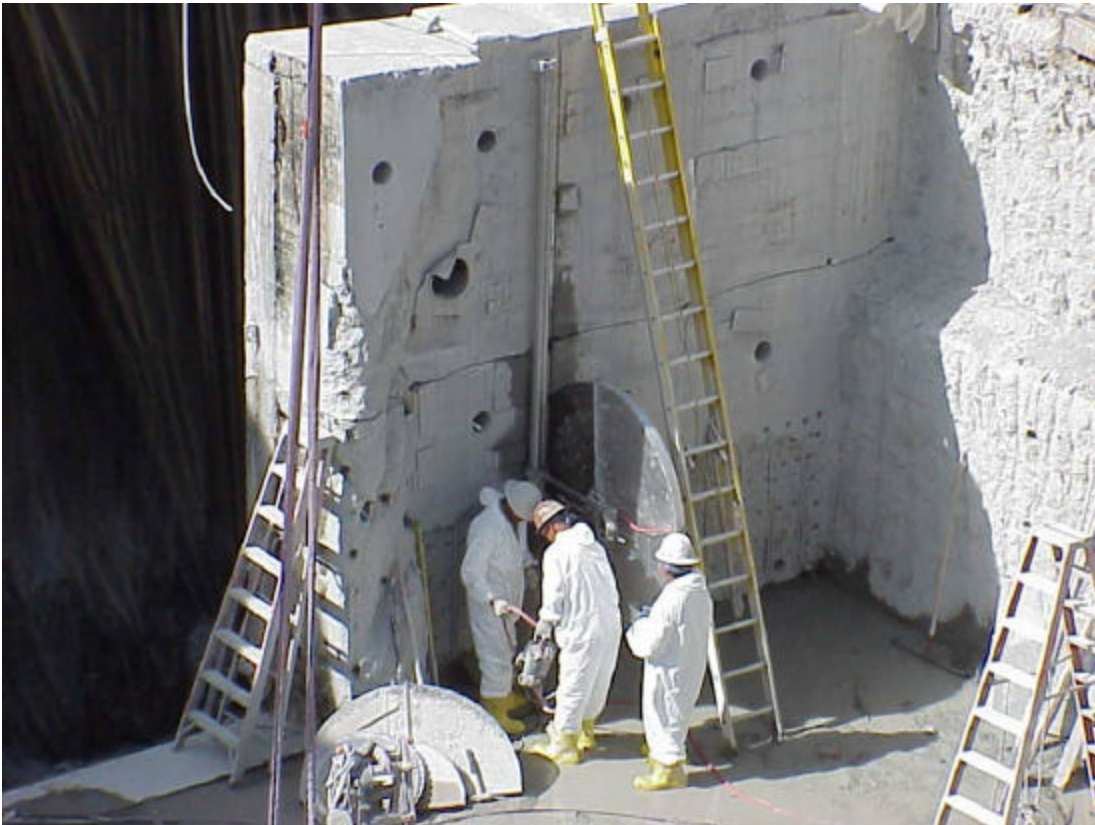
***Figure 2.6.3.6 5-ft Diameter Blade Saw Being Used in Wall***

One of the main concerns for the concrete cutting operation was the control and minimization of contaminated water generation. The concrete cutting process uses water to cool the cutting area and aid the process. Because the water was contaminated, it needed to be contained and a process needed to be in place to minimize the total volume. Spilled or released cutting fluids could jeopardize a project goal of meeting the radiological release limits once the blocks were removed. The subject of cutting water control was stressed in the specification for the contract. The selected contractor used collection systems to contain the water within the facility and also recycled the collected water back to the equipment. These actions resulted in less than a 5,000 gallon inventory of water to be processed by the end of the work.

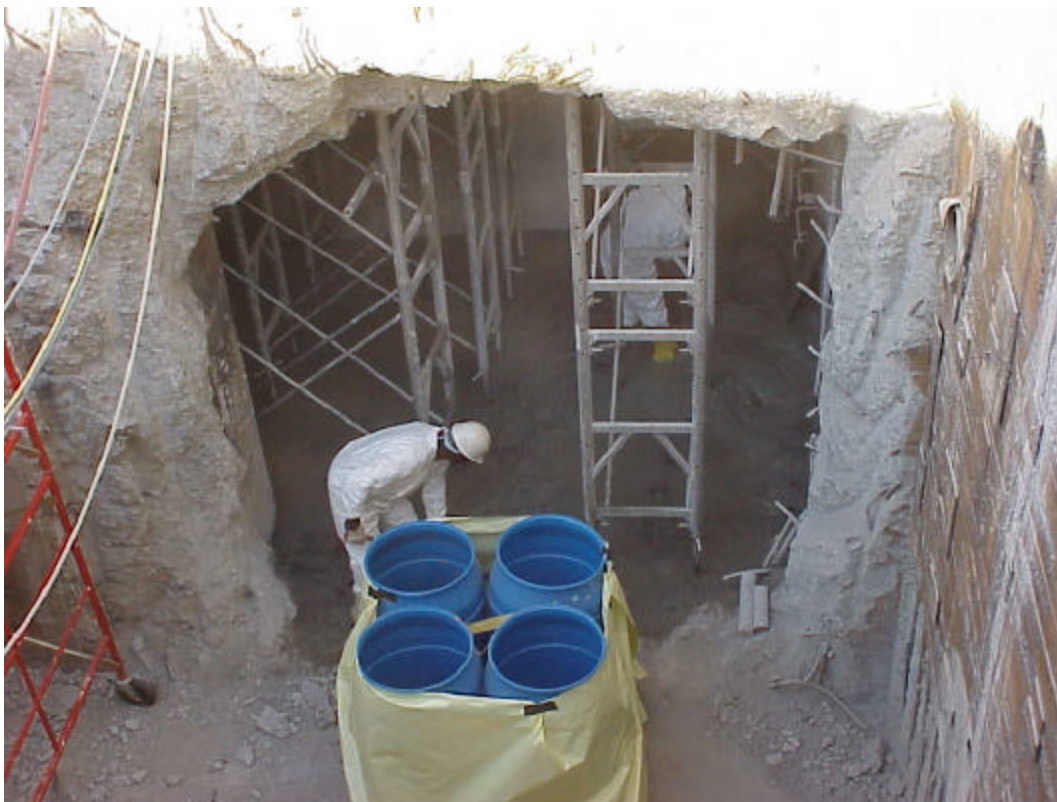
*Figure 2.6.3.8 PCR Scaffolding to Support Floor Blocks During Cutting*

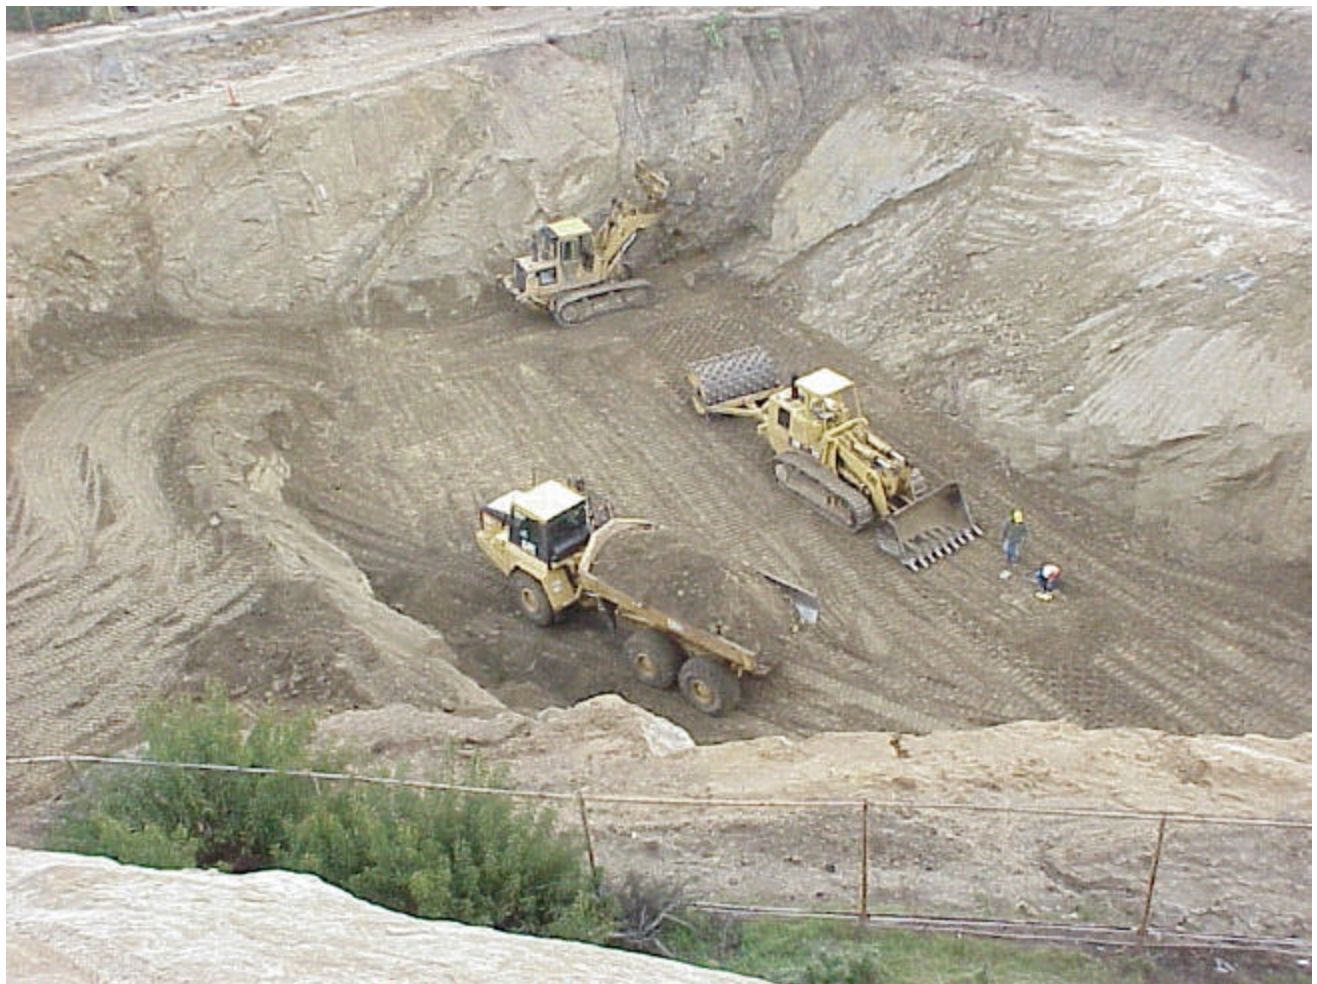
***Figure 2.6.4.1 Building 059 Excavation Backfill Process***

Surveys of contractor equipment were performed and support contractors had moved offsite by the end of September, 2004. Contamination surveys, small cleanup actions and company owned equipment disposition were completed. The internal MARRSIM compliant final survey of the site has been completed and a report will be issued. Verification surveys were completed by the DHS and ORISE prior to initiation of backfill. The excavation was then backfilled to 90% compaction or better. Figures 2.6.4.1 and 2.6.4.2 show the backfill and compaction and the compaction verification process respectively. Figure 2.6.4.3 shows an aerial view when the excavation was about 85% completed.

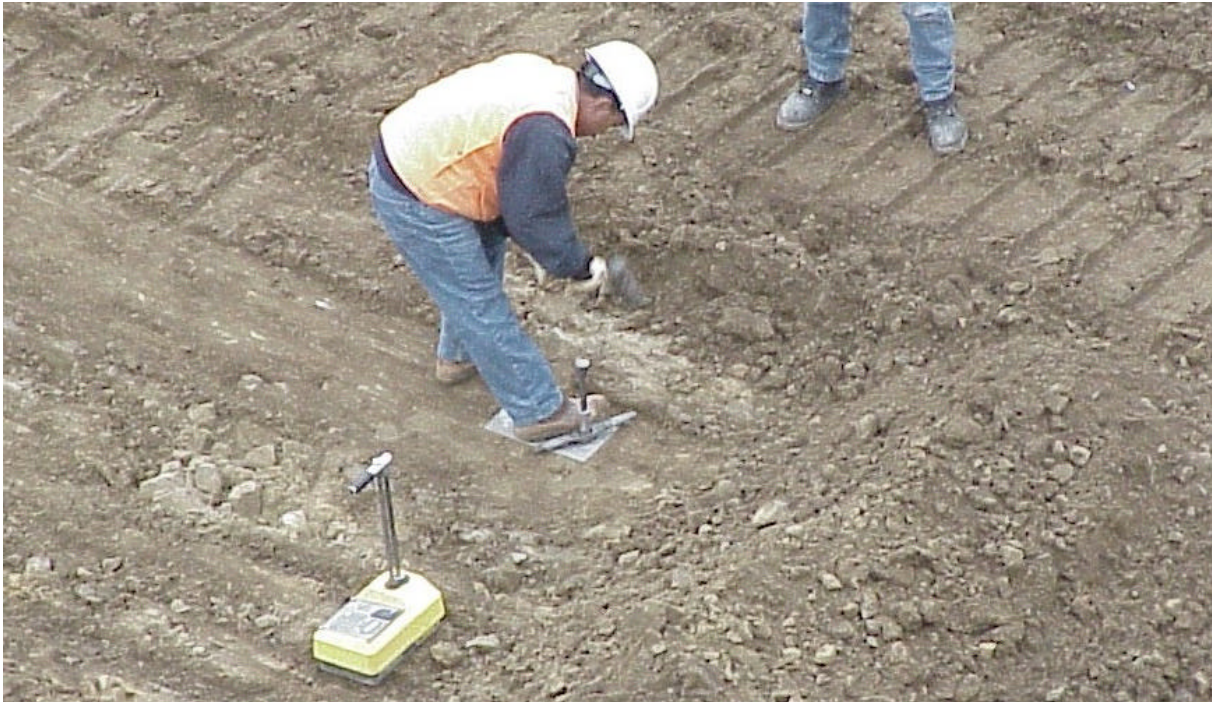
***Figure 2.6.4.2 90% Plus Compaction Verification***
